**Flood Control Project Maintenance
Levee Inspections**
LMA District Cover Sheet
Spring 2018 Levee Inspection Results

Reclamation District No. 0501 Ryer Island

Spring 2018 Levee Inspection Results

Waterway			Bank	Unit Miles
Unit No. 01 Steamboat Slough			Right	6.71
	Spring (March - May)	Summer (June - August)	(September - November) Fall	Winter (December - February)
Unit Maintenance Rating (Fall Only)				
Date of Inspection	3/13/2018 - 3/13/2018			
DWR Inspector	Keith Millard			
Accompanied By

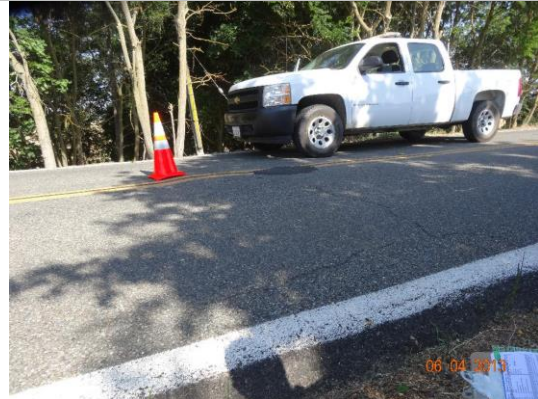
Photo 1 of 3 : UCIP_SP_2018_50063_58923.jpg

FS_ID:50063
DS_ID:21030
EP_NO: 4581
Repair Type: Urgent
Crossing Status: Found
UCIP Comments: 8/22/2016 Sacramento County has re-paved road and patch is no longer present. Crossing remains to be Urgent due to the unknown condition of the section of the levee along pipe alignment. Unable to determine if any internal erosion is present along pipe. According to LMA representative, Stacy Boyd, no additional sink holes have developed since 2013. No sink holes have been noticed since PVC pipe was sleeved through existing steel pipe. Permit authorizing work is not available. Need to identify current owner. Owner will need to coordinate with CVFPB to remove or abandon crossing per Title 23 requirements. (DWR UCIP - omagana)6/04/2013 Damage present on levee crown--unable to confirm if damage due to leak in pipe. Signs of repair work on crown, however, no permit found to document recent damage to levee or repair work. New PVC pipe has been sleeved through the existing 6-inch pipe. Unable to determine if crossing is still in use, if not, crossings needs to be removed according to CVFPB Title 23 requirements. (DWR UCIP - omagana)

View of crown at crossing.

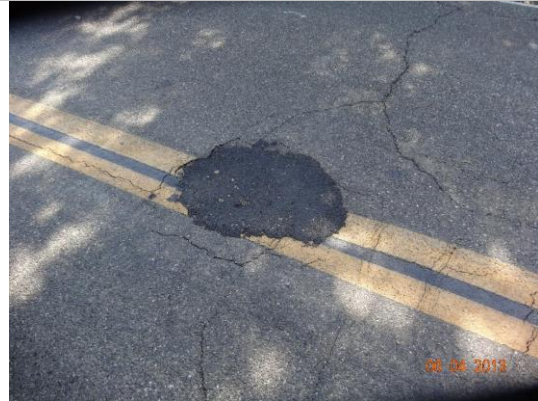
Photo 2 of 3 : UCIP_SP_2018_50063_58922.jpg

FS_ID:50063
DS_ID:21030
EP_NO: 4581
Repair Type: Urgent
Crossing Status: Found
UCIP Comments: 8/22/2016 Sacramento County has re-paved road and patch is no longer present. Crossing remains to be Urgent due to the unknown condition of the section of the levee along pipe alignment. Unable to determine if any internal erosion is present along pipe. According to LMA representative, Stacy Boyd, no additional sink holes have developed since 2013. No sink holes have been noticed since PVC pipe was sleeved through existing steel pipe. Permit authorizing work is not available. Need to identify current owner. Owner will need to coordinate with CVFPB to remove or abandon crossing per Title 23 requirements. (DWR UCIP - omagana)6/04/2013 Damage present on levee crown--unable to confirm if damage due to leak in pipe. Signs of repair work on crown, however, no permit found to document recent damage to levee or repair work. New PVC pipe has been sleeved through the existing 6-inch pipe. Unable to determine if crossing is still in use, if not, crossings needs to be removed according to CVFPB Title 23 requirements. (DWR UCIP - omagana)

Subsidence and patch work repair on crown.

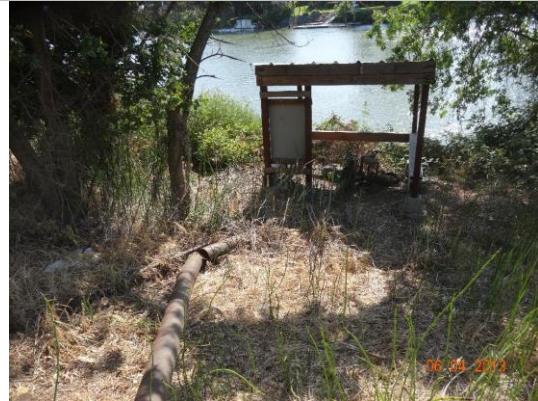
Photo 3 of 3 : UCIP_SP_2018_50063_58924.jpg

FS_ID:50063
DS_ID:21030
EP_NO: 4581
Repair Type: Urgent
Crossing Status: Found
UCIP Comments: 8/22/2016 Sacramento County has re-paved road and patch is no longer present. Crossing remains to be Urgent due to the unknown condition of the section of the levee along pipe alignment. Unable to determine if any internal erosion is present along pipe. According to LMA representative, Stacy Boyd, no additional sink holes have developed since 2013. No sink holes have been noticed since PVC pipe was sleeved through existing steel pipe. Permit authorizing work is not available. Need to identify current owner. Owner will need to coordinate with CVFPB to remove or abandon crossing per Title 23 requirements. (DWR UCIP - omagana)6/04/2013 Damage present on levee crown--unable to confirm if damage due to leak in pipe. Signs of repair work on crown, however, no permit found to document recent damage to levee or repair work. New PVC pipe has been sleeved through the existing 6-inch pipe. Unable to determine if crossing is still in use, if not, crossings needs to be removed according to CVFPB Title 23 requirements. (DWR UCIP - omagana)

Overview of WS--pump, abandoned pipe section, and conduit.

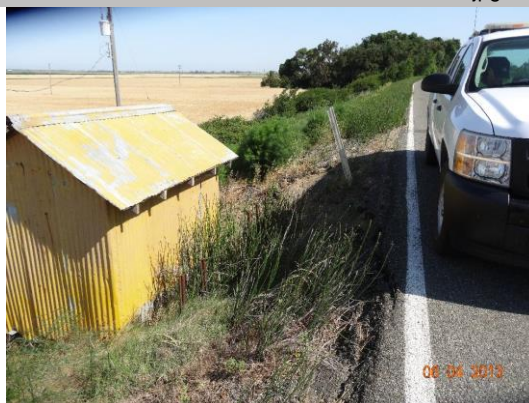
Photo 2 of 3 : UCIP_SP_2018_32524_58927.jpg

FS_ID:32524
 DS_ID:21031
 EP_NO: N/A
 Repair Type: Non-Urgent
 Crossing Status: Found
 UCIP Comments: Dense vegetation limits the inspector's visibility to identify signs of leaks through the slope. Recommend removing vegetation along pipe alignment for reinspection. Need to contact the owner to clear slope along crossing.
 FIELD_STRUCT_DESC: 20-inch irrigation discharge pipe of an unknown material and a 2.5-inch electrical conduit of an unknown material through the levee, both 7.8 feet below the crown. Pump and gate valve in a pump house on the landside (LS) slope. Pipe exposed along the waterside (WS) slope. [Additional Reference(s): DWR Levee Log, 2005. USACE Sacramento O&M Manual 105, April 1959, (HLM 0.4), irrigation siphon referenced].
 FS Date: 6/4/2013

Overview of landside. Pump house and power pole visible on landward side.

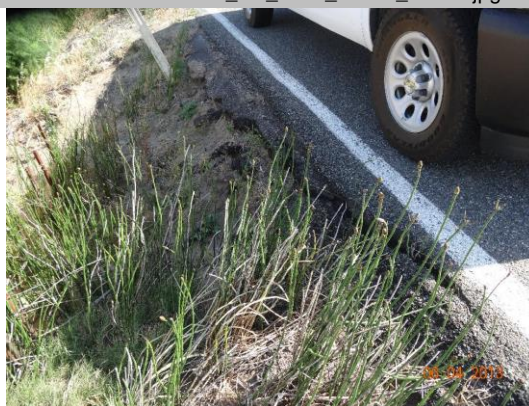
Photo 3 of 3 : UCIP_SP_2018_32524_58925.jpg

Item	DWR UCIP Field Study		38.249197 °	38.249197 °								
			-121.603061 °	-121.603061 °								
DWR ID												
Comment Code												
Inspector Comment												
FS_ID:32524 DS_ID:21031 EP_NO: N/A Repair Type: Non-Urgent Crossing Status: Found UCIP Comments: Dense vegetation limits the inspector's visibility to identify signs of leaks through the slope. Recommend removing vegetation along pipe alignment for reinspection. Need to contact the owner to clear slope along crossing. FIELD_STRUCT_DESC: 20-inch irrigation discharge pipe of an unknown material and a 2.5-inch electrical conduit of an unknown material through the levee, both 7.8 feet below the crown. Pump and gate valve in a pump house on the landside (LS) slope. Pipe exposed along the waterside (WS) slope. [Additional Reference(s): DWR Levee Log, 2005. USACE Sacramento O&M Manual 105, April 1959, (HLM 0.4), irrigation siphon referenced]. FS Date: 6/4/2013

Crown hinge point damaged, roadway section missing.

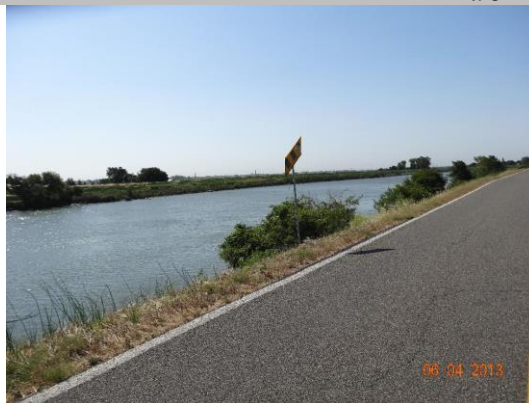
Photo 1 of 3 : UCIP_SP_2018_41409_58931.jpg

Comment Code					
Inspector Comment					
FS_ID:41409					
DS_ID:21032					
EP_NO: N/A					
Repair Type: Non-Urgent					
Crossing Status: Found					
UCIP Comments: Need to contact owner and ask for emergency					
contact information and permit number. 8/21/13 Contacted Gas					
Control Division under the emergency contact No. 1-877-723-3344.					
Message has been forward to Brian Habersack at 916-859-4700, email:					
bhabsack@gasbiz.com.					
FIELD_STRUCT_DESC: 6-inch steel natural gas pipeline under the					
levee, 60 feet below the crown. Gas line marker on each shoulder.					
(Plans to install a 6-inch steel natural gas pipeline across and bored					
under the channel and each levee authorized under Permit No. 17033,					
1999 - Delta Gas Gathering, Inc., and A. A. Production Services, Inc.).					
[Additional Reference(s): DWR Levee Log, 2005].					
FS Date: 6/4/2013

Overview of waterside at crossing. Marker on shoulder.

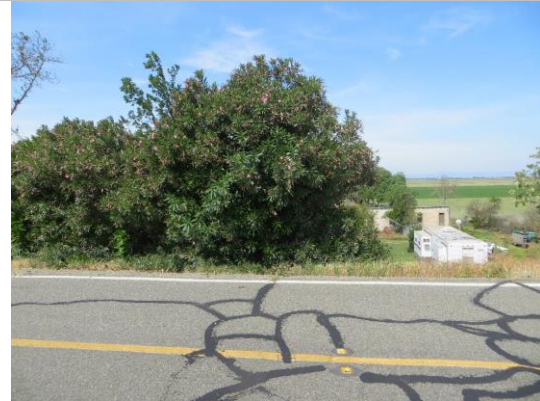
Photo 3 of 3 : UCIP_SP_2018_44643_73840.jpg

Comment Code						
Inspector Comment						
FS_ID:44643 DS_ID:21089 EP_NO: 2683 Repair Type: Non-Urgent Crossing Status: Indicator Found UCIP Comments: Appears abandoned and if so should be done so properly. FIELD_STRUCT_DESC: *ABANDONED* 2-inch steel water pipe and a 1-inch steel electrical conduit through the levee, both 3 feet below the crown. Portion of pipe visible under the oleanders on the landside (LS) shoulder, may be part of this crossing. No evidence remains on the waterside (WS) slope. (Plans for installation of an electrical conduit and a water pipe through the levee authorized under Permit No. 2683, 1957 - John Gosner). FS Date: 4/21/2015

Pipes visible under oleander on LS shoulder.

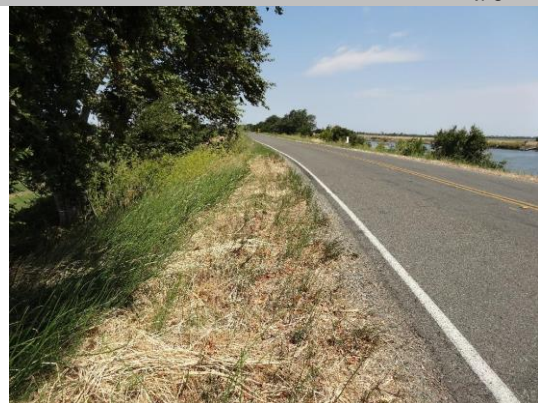
Photo 1 of 3 : UCIP_SP_2018_50020_75648.jpg

Comment Code						
Inspector Comment						
FS_ID:50020 DS_ID:21034 EP_NO: N/A Repair Type: Non-Urgent Crossing Status: Found UCIP Comments: 8/22/2016 Crossing has been downgraded from Urgent to Non-Urgent -- no evidence of damage to levee is present. Dense vegetation limits the inspector's visibility to identify signs of pipe failure (leaks) through he slope. Recommend removing vegetation along pipe alignment to conduct proper inspection of structure and appurtenances. Also will need to coordinate with owner to determine if permit was obtained for the modifications made to crossing (PVC pipe sleeved through existing pipe). (DWR UCIP - omagana)4/21/2015 Unauthorized PVC pipe. Annular space not grouted. 14-inch pipe open on both ends. (DWR UCIP - omagana) FIELD_STRUCT_DESC: 14-inch steel irrigation siphon pipe through the levee, 3.2 feet below the crown. 10-inch polyvinyl chloride (PVC) pipe sleeved through the 14-inch pipe. Siphon breaker on the landside (LS) shoulder. [Additional Reference(s): DWR Levee Log, 2005. USACE Sacramento O&M Manual 105, April 1959, (HLM 1.0)]. FS Date: 8/22/2016

View of levee crown and LS shoulder.

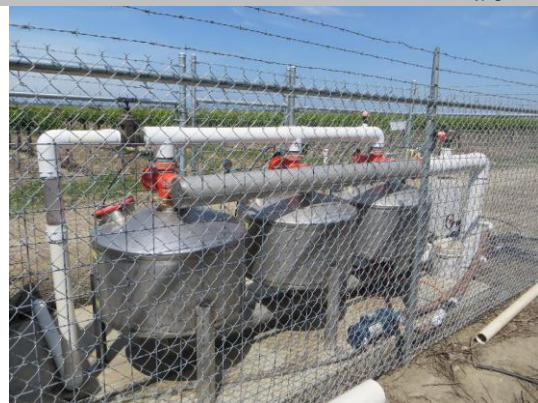
Photo 1 of 3 : UCIP_SP_2018_47516_73857.jpg

Comment Code						
Inspector Comment						
FS_ID:47516 DS_ID:21086 EP_NO: 13233 Repair Type: Non-Urgent Crossing Status: Found UCIP Comments: Annular space between pipes not grouted. FPIIB Inspector Herman Phillips will contact owner regarding lack of permit for sand filters. Steel plate partially covers openings between pipes. FIELD_STRUCT_DESC: 14-inch coated steel irrigation discharge pipe through the levee, 2.5 feet below the crown. 8-inch steel pipe sleeved through the 14-inch pipe. Cutoff wall around the pipe at the center of the levee. Pump and check valve in a pump house on the waterside (WS) slope. Service pole on the landside (LS) slope. A 1.5-inch and a 2.5-inch electrical conduits at the same location. Siphon breaker on each shoulder. (Plans to replace a 12-inch irrigation pipe through the levee authorized under Permit No. 11813, 1976 - Harry H. Rasmussen. Plans to replace irrigation pipe with a 14-inch pipe through the levee authorized under Permit No. 13233, 1981 - Harry H. Rasmussen. Plans to install an 8-inch steel pipe through an existing 14-inch pipe through the levee authorized under Permit No. 11813-1, 2013 - Matt Davis). FS Date: 4/21/2015

Sand filter plant on LS toe.

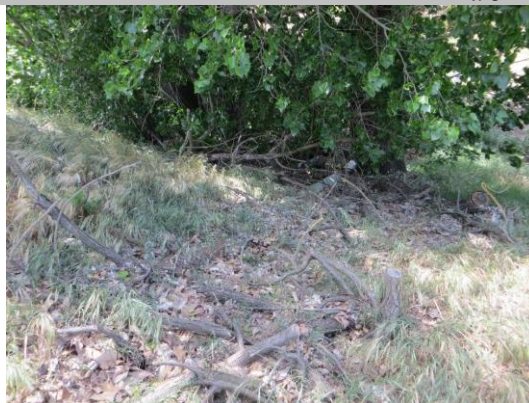
Photo 1 of 3 : UCIP_SP_2018_44683_73882.jpg

LM Start	2.34	Rating **	M	Issue No.	986	
LM End	2.34	Issue Type +	En	Location *		
Category	Supplemental			GPS Latitude/Longitude		
				Start		End
Item	DWR UCIP Field Study			38.221277 °	38.221277 °	
				-121.603505 °	-121.603505 °	
DWR ID						
Comment Code						
Inspector Comment						
FS_ID:44683 DS_ID:21021 EP_NO: N/A Repair Type: Non-Urgent Crossing Status: Found UCIP Comments: Appears abandoned and if so should be done so properly. Discarded pipe on WS slope should be removed. FIELD_STRUCT_DESC: 10-inch steel irrigation discharge pipe through the levee, 2.5 feet below the crown. Pump and gate valve in a pump house on the waterside (WS) slope. 4-foot by 4-foot concrete distribution box, power pole, and meter at the landside (LS) toe. [Additional Reference(s): DWR Levee Log, 2005. USACE Sacramento O&M Manual 105, April 1959, (HLM 2.5)]. FS Date: 4/21/2015

Pipe visible on LS slope.

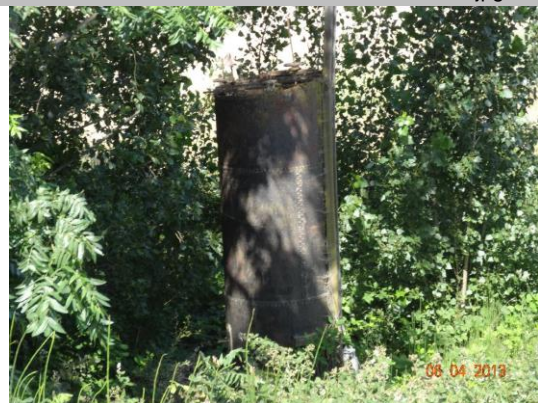
Photo 3 of 3 : UCIP_SP_2018_32526_58934.jpg

FS_ID:32526
DS_ID:21022
EP_NO: 2742
Repair Type: Non-Urgent
Crossing Status: Found
UCIP Comments: Dense vegetation limits the inspector's visibility to identify signs of pipe failure (leaks) through the levee slopes. Recommend removing vegetation along pipe alignment to conduct proper inspection of structure and appurtenances. Additional notes: pump was running during inspection, 16-inch pipe debris section located on landward side, view of standpipe and support structure on waterward side does not match structure description--need to determine if crossing has been altered.
FIELD_STRUCT_DESC: 16-inch coated steel drainage discharge pipe through the levee, 3.6 feet below the crown. Cutoff walls around the pipe at the center of the levee. Siphon breaker on the apex of the pipe on the landside (LS) shoulder. Pump house on the LS shoulder. Pipe discharges into a 48-inch pipe with a screw gate on the LS. Rock revetment placed on the waterside (WS) slope. Revegetation in progress on the WS. (Plans to install a 16-inch siphon through the levee authorized under Permit No. 2742, 1958 - Reclamation District No. 501 [RD0501]. Plans to replace a portion of an existing 16-inch discharge pipe through the levee authorized under Permit No. 15380, 1999 - RD0501). [Additional Reference(s): DWR Levee Log, 2005].

Standpipe on landward toe.

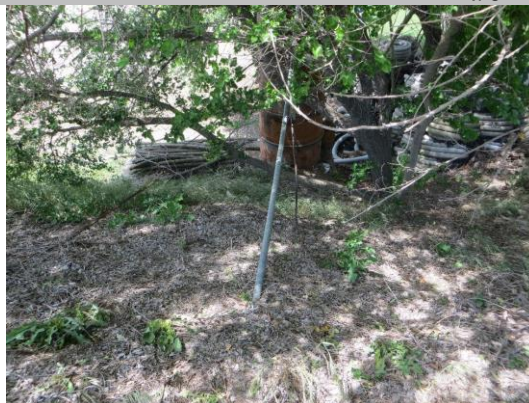
Photo 1 of 2 : UCIP_SP_2018_44688_73891.jpg

Pipe visible at LS shoulder. Pipe connects to top of steel standpipe at LS toe.

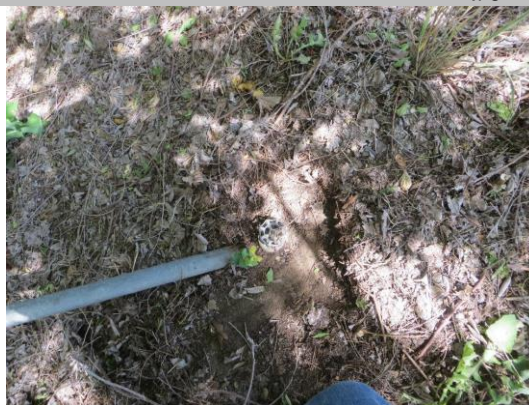
Photo 2 of 2 : UCIP_SP_2018_44688_73890.jpg

Shutoff valve at LS shoulder.

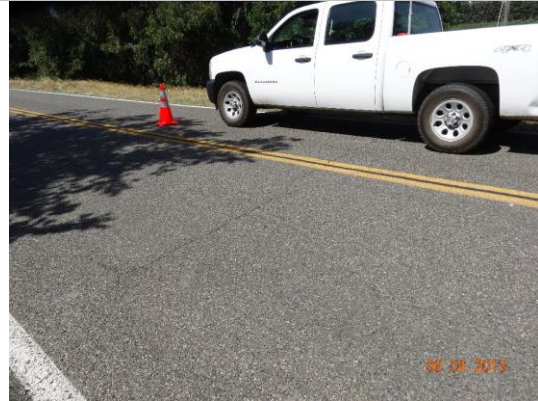
Photo 1 of 3 : UCIP_SP_2018_50022_58942.jpg

View of levee crown at crossing. Single line crack on levee crown.

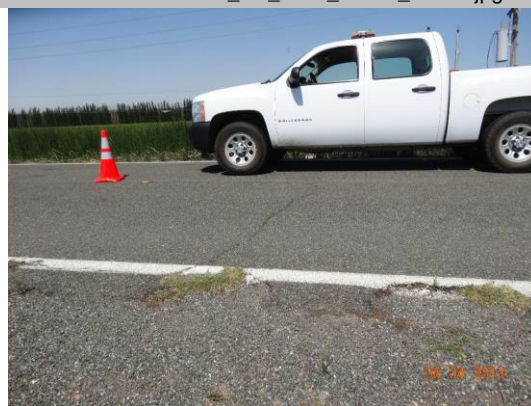
Photo 1 of 3 : UCIP_SP_2018_32529_58954.jpg

Single line crack on crown.

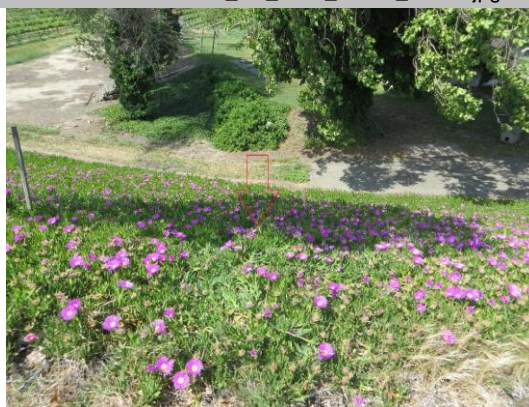
Photo 2 of 3 : UCIP_SP_2018_44720_73903.jpg

Mound at pipe visible on LS slope.

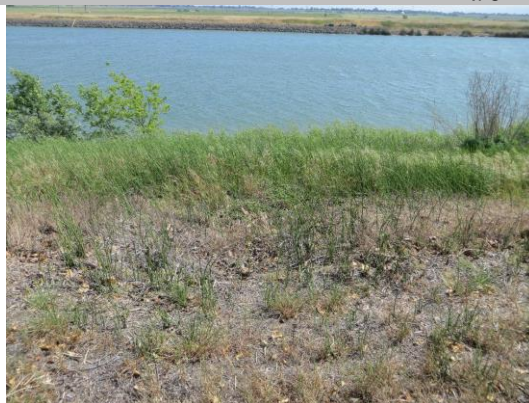
Photo 3 of 3 : UCIP_SP_2018_44720_73902.jpg

Depression on WS shoulder across from pipe may be a good indicator of pipe location.

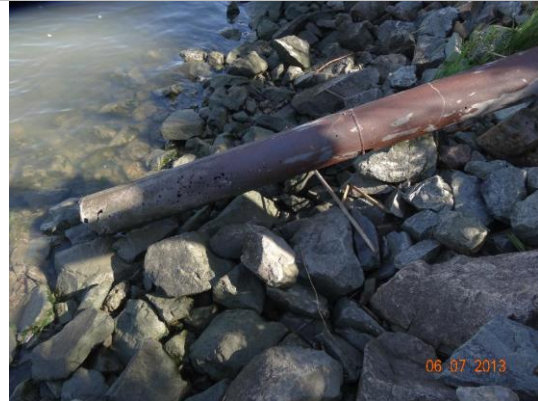
Photo 3 of 3 : UCIP_SP_2018_50018_58966.jpg

Deteriorated pipe with visible holes through pipe wall.

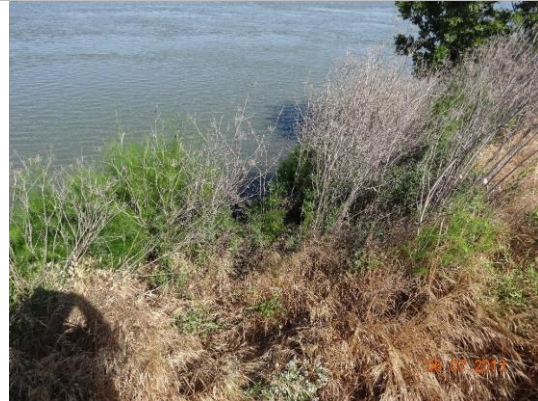
Photo 3 of 3 : UCIP_SP_2018_50019_58969.jpg

View of waterward side--dense vegetation limits inspection. Unable to locate pipe on waterward side.

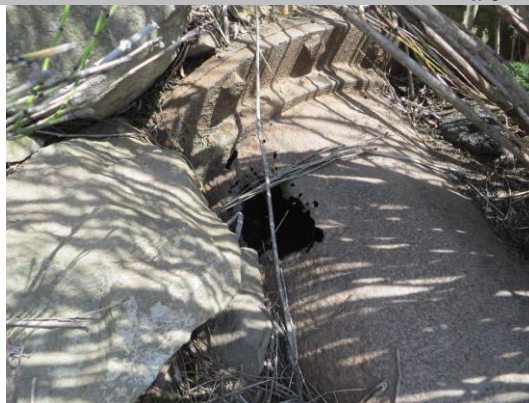
Photo 2 of 3 : UCIP_SP_2018_44753_73954.jpg

Hole in pipe at WS toe.

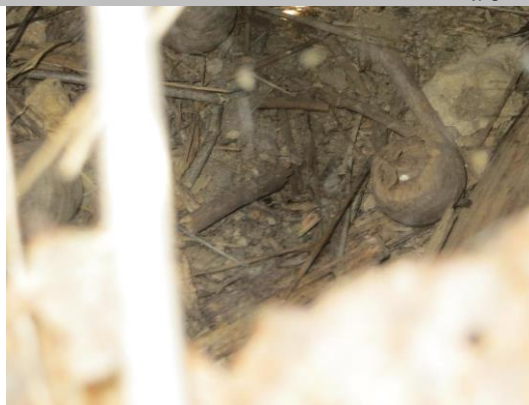
Photo 3 of 3 : UCIP_SP_2018_44753_73953.jpg

Inside hole in pipe at WS toe.

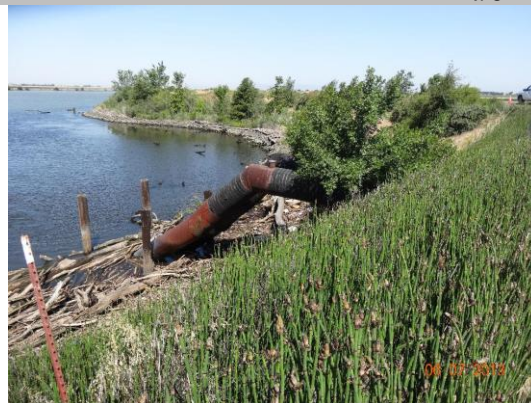
Photo 3 of 3 : UCIP_SP_2018_47049_33374.jpg

View of exposed pipe section on waterward side.

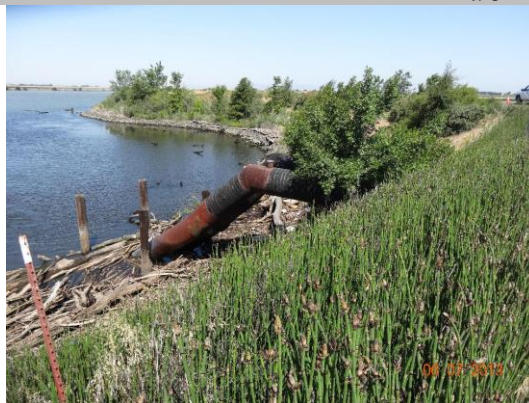
Photo 3 of 3 : UCIP_SP_2018_47050_33368.jpg

View of 36 inch pipes exposed on waterward side.

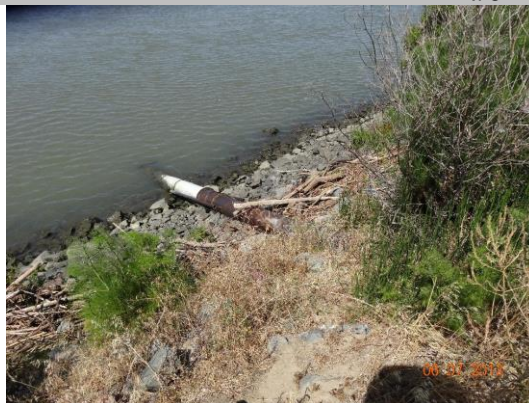
Photo 3 of 3 : UCIP_SP_2018_32537_58988.jpg

View of exposed section of pipe at waterward toe.

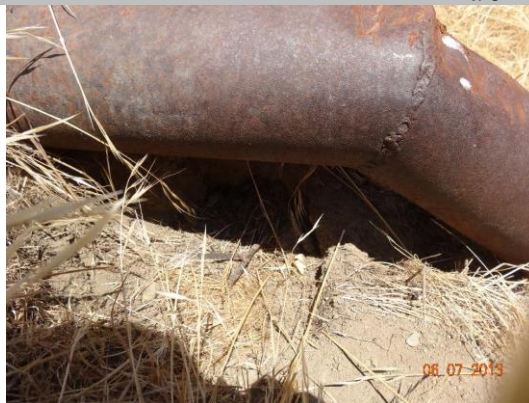
Photo 2 of 3 : UCIP_SP_2018_46768_30381.jpg

Burrow activity visible underneath pipe alignment.

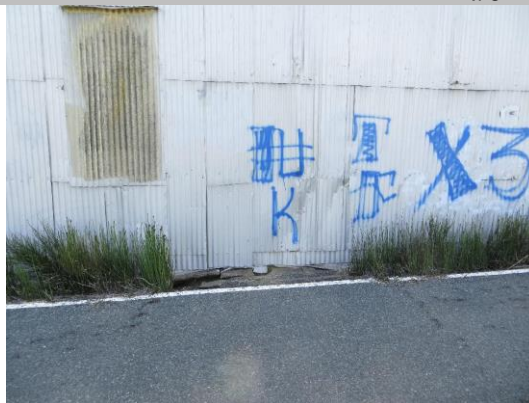
Photo 1 of 3 : UCIP_SP_2018_50023_73942.jpg

Building on LS shoulder prevents access to LS of levee.

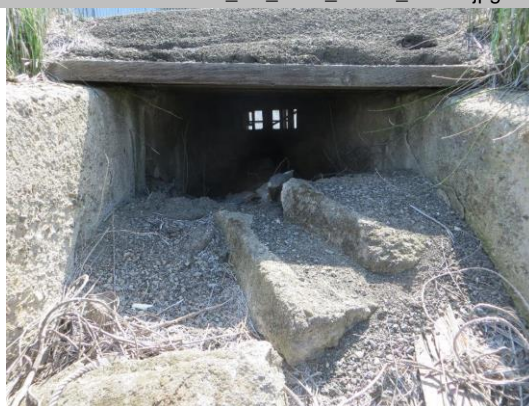
Photo 3 of 3 : UCIP_SP_2018_50023_73940.jpg

Tunnel open on both ends.

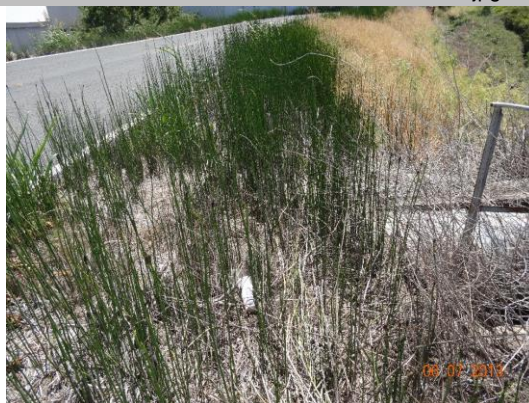
Photo 2 of 3 : UCIP_SP_2018_19662_33418.jpg

Dense vegetation along the pipe alignment and throughout waterward slope.

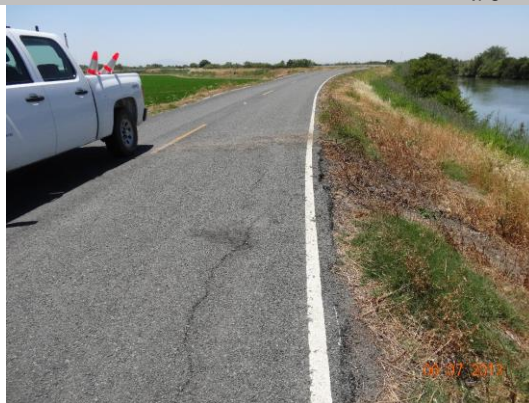
Photo 1 of 3 : UCIP_SP_2018_44876_33427.jpg

Line cracks along crown near crown hinge point on waterward side.

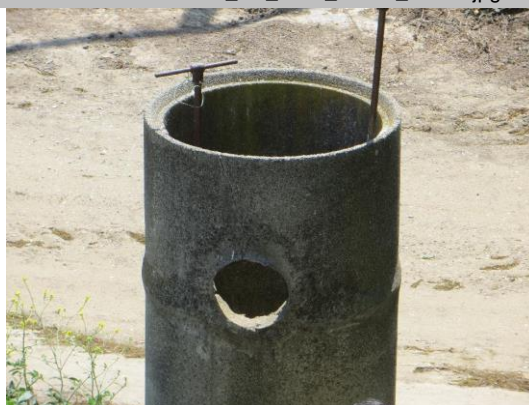
Photo 2 of 2 : UCIP_SP_2018_44746_73943.jpg

10-inch diameter hole cut in side of standpipe where pipe once was installed.

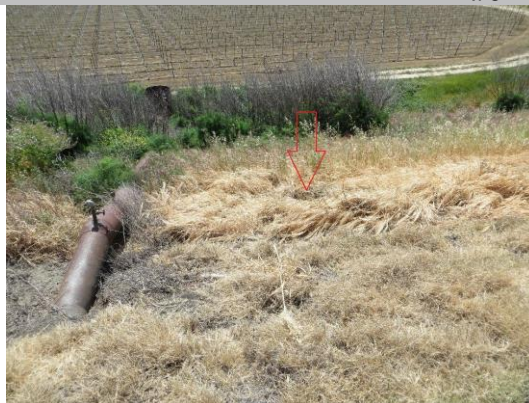
Photo 1 of 2 : UCIP_SP_2018_44877_73946.jpg

Buried pipe exposed in trench 8-feet downstream from visible pipe.

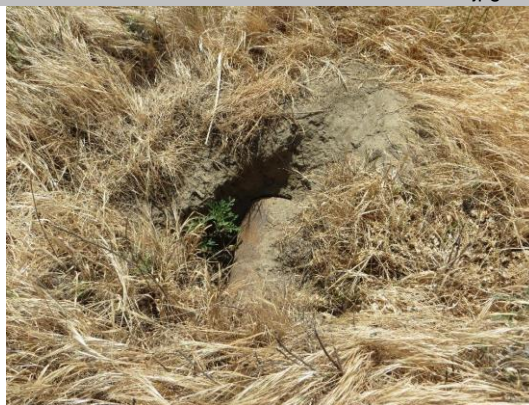
Photo 2 of 2 : UCIP_SP_2018_44877_73945.jpg

Cut in buried pipe on LS shoulder.

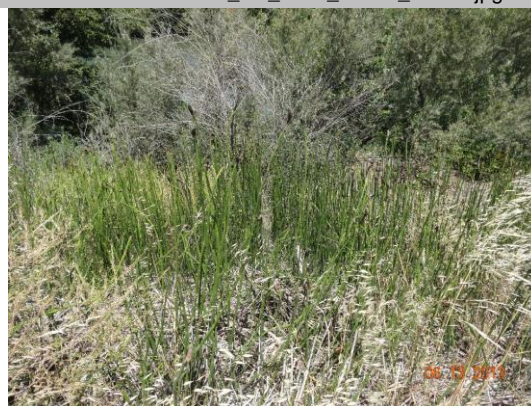
Photo 3 of 3 : UCIP_SP_2018_32543_59026.jpg

View of waterward side. Dense vegetation along levee slope.

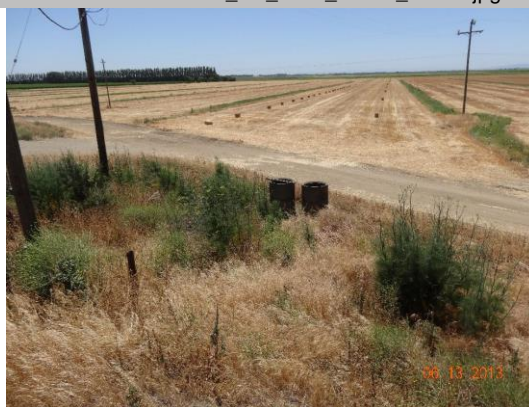
Photo 3 of 3 : UCIP_SP_2018_32544_59036.jpg

Dry vegetation throughout the landward slope.

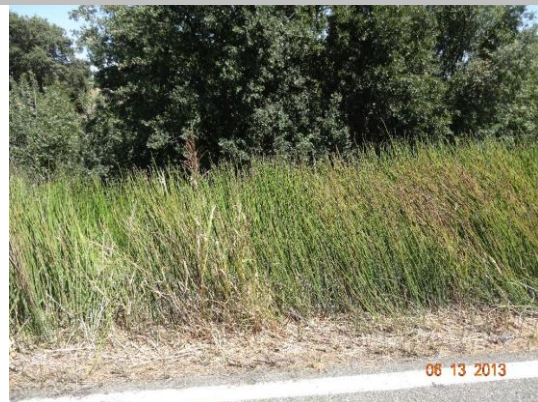
Photo 3 of 3 : UCIP_SP_2018_50021_59064.jpg

High vegetation along waterward side.
